**DEPARTMENT OF TRANSPORTATION**

Contract #: 04-0120F4Cty: SF/ALA Rte: 80 PM: 13.2/13.9File #: 1.28**WELDING INSPECTION REPORT****Resident Engineer:** Casey, William**Address:** 333 Burma Road**City:** Oakland, CA 94607**Report No:** WIR-027241**Date Inspected:** 25-Feb-2012**Project Name:** SAS Superstructure**OSM Arrival Time:** 700**Prime Contractor:** American Bridge/Fluor Enterprises, a JV**OSM Departure Time:** 1530**Contractor:** American Bridge/Fluor Enterprises, a JV**Location:** Job Site**CWI Name:** See Below**CWI Present:** Yes No**Inspected CWI report:** Yes No N/A**Rod Oven in Use:** Yes No N/A**Electrode to specification:** Yes No N/A**Weld Procedures Followed:** Yes No N/A**Qualified Welders:** Yes No N/A**Verified Joint Fit-up:** Yes No N/A**Approved Drawings:** Yes No N/A**Approved WPS:** Yes No N/A**Delayed / Cancelled:** Yes No N/A**Bridge No:** 34-0006**Component:** OBG/Tower**Summary of Items Observed:**

## WELDING INSPECTION REPORT

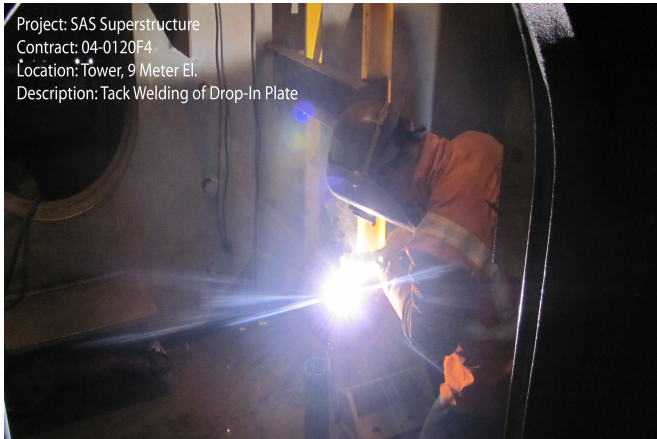
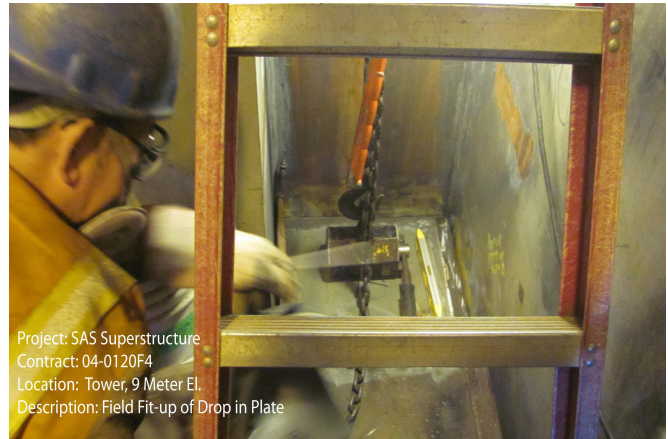
This QAI observed the Flux Cored Arc Welding (FCAW-G) and the Shielded Metal Arc Welding (SMAW) processes of the drop-in plates identified as Weld Number (WN): 063-1,2, 3,4 and 064-1, 2, 3 & 4 . The Partial Joint Penetration (PJP) groove welding was performed by welding personnel James Zhen ID-6001 and Wai Kitlai ID-2953 utilizing the Welding Procedure Specifications (WPS) ABF-WPS-D15-1160, Rev. 0 (root pass) and ABF-WPS-D15-3160-1, Rev. 0 (fill pass). The WPS's were also used by the AB/F Quality Control (QC) Inspector Bernie Docena as a reference during the monitoring and verifying the welding parameters. The QAI also observed the QC inspector verifying the welding parameters for the welder Mr. Zhen and were observed by this QAI as follows: 255 amps, 24.5 volts and a travel speed measured at 295mm/minute. Later in the shift this QAI also observed the QC inspector verifying the welding parameters for the welder Mr. Kitlai and were observed as follows: 275 amps, 24.0 volts and a travel speed measured at 302 mm/minute. The QC inspector also monitored the surface temperatures during the field welding and the following was observed and noted by the QAI: the minimum preheat temperature of 125 degrees Celsius and the maximum interpass temperature of 230 degrees Celsius.

In regards to WN: 063-2 during the Magnetic Particle Testing (MPT) of the root pass it was noted by the QC inspector that there a crack for approximately the full length of the weld. An incident report was generated regarding this issue.

See attached digital photographs, below, for some of the work observed during this shift.

In conversation with QC Project Lead Inspector Mr. Daquinag, Jr. this QAI was informed that this issue would be submitted to Jim Bowers, Welding Quality Control Manager, for his review and disposition.
